**Asbestos Survey/Inspection**

**Former Norco Refinery  
FM 2725 & Bishop Road  
Ingleside, Texas**

**PSI Project No. 435-4A061**

**September 14, 2004**

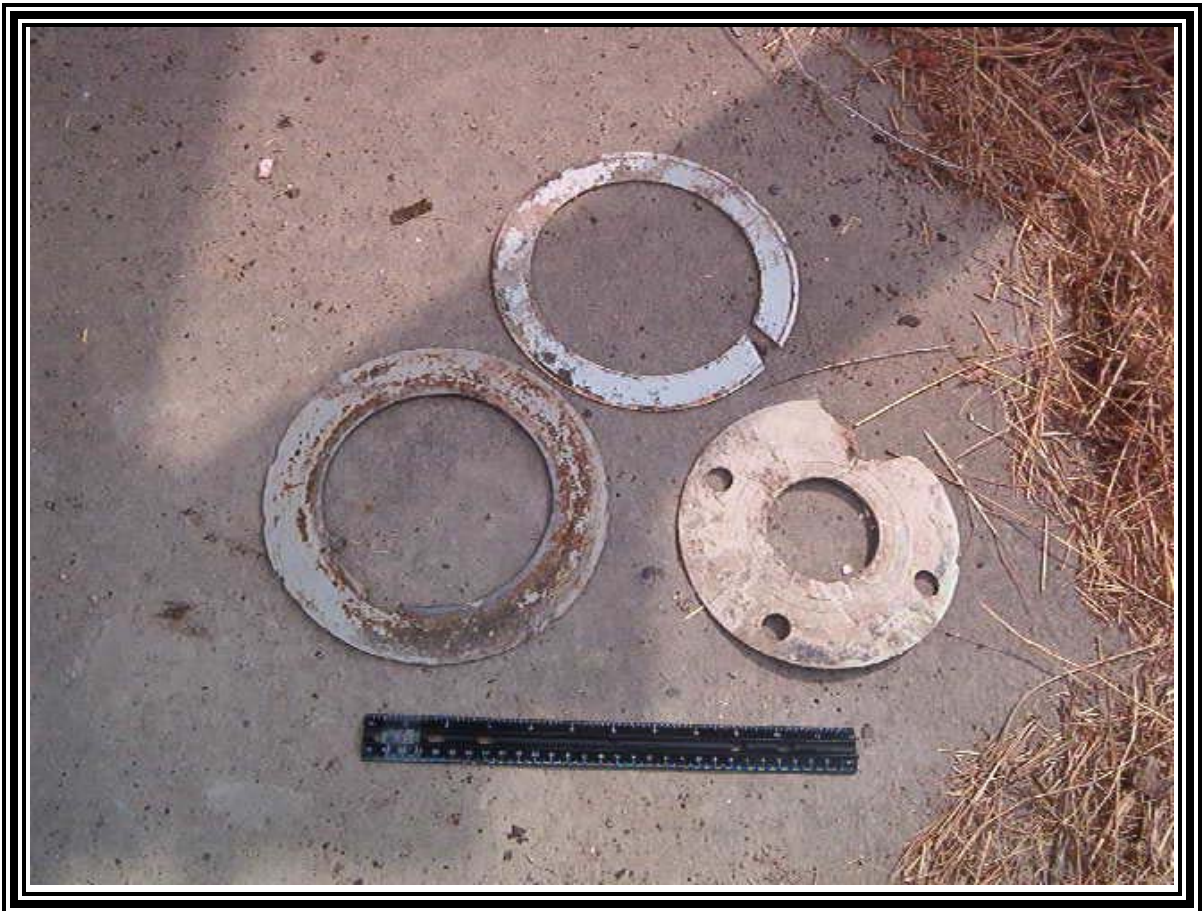
<sup>1</sup> As indicated by the analytical data, a variety of gasket materials have been utilized throughout the Former Norco Refinery. The analytical results indicate the gaskets sampled ranged from NAD to 65% Chrysotile asbestos; therefore, all discarded gaskets found on the ground and those encountered during the dismantling of the piping, smokestacks, and storage tanks should be assumed to be asbestos-containing and treated accordingly.

1. View of typical gasket materials found on the ground throughout the Former Norco Refinery.

- A. Homogeneous Area No. 05 consists of an indeterminable quantity of gasket materials presumably located throughout the joints/fittings and pipe flanges throughout Area A. In addition, discarded gaskets were also observed on the ground at various locations throughout Area A. The extents could not be feasibly determined by the inspector at the time of the survey. These materials are friable and in damaged condition. The gasket materials sampled in Area A were found to contain up to 20% Chrysotile asbestos. As indicated by the analytical data, a variety of gasket materials have been utilized throughout Area A; therefore, all discarded gaskets found on the ground and those encountered during the dismantling of the piping, smokestacks, and storage tanks should be assumed to be asbestos-containing. Due to the difficult nature of abating the gasket materials prior to the dismantling/demolition of the facility, PSI recommends that BNC Engineering, a TDH licensed asbestos abatement contractor, and a TDH licensed individual asbestos consultant coordinate efforts in order to devise a method of abatement that is in accordance with all applicable state and federal regulations. The method of abatement selected should then be incorporated into the design phase of the project.

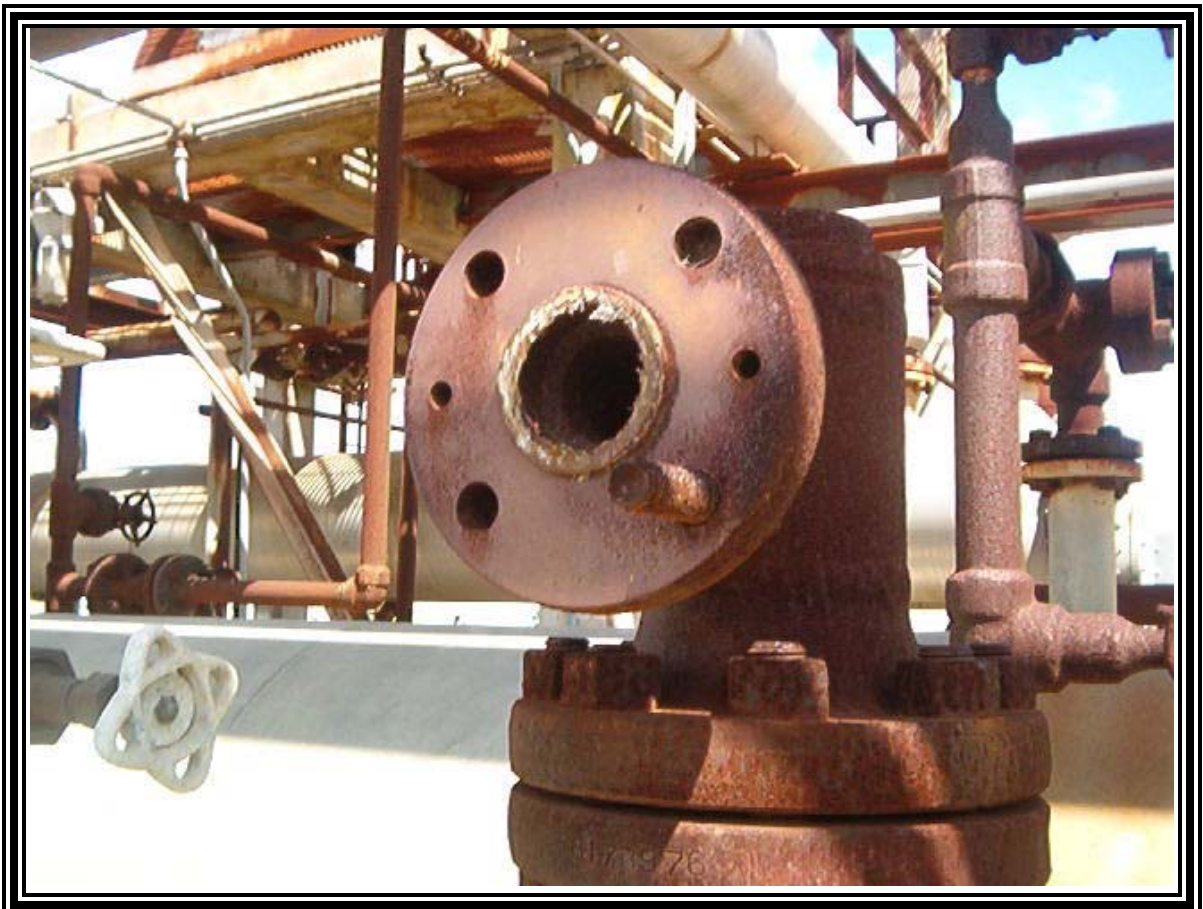
2. View of remnant gasket material located on flange at removed section of piping.

- I. Homogeneous Area No. 37 consists of an indeterminable quantity of gasket materials presumably located throughout the joints/fittings and pipe flanges throughout Area G. In addition, discarded gaskets were also observed on the ground at various locations throughout Area G. The extents could not be feasibly determined by the inspector at the time of the survey. These materials are friable and in damaged condition. The gasket materials sampled in Area G were found to contain 65% Chrysotile asbestos. Based on the non-homogeneous nature of the gasket materials utilized throughout the facility, all discarded gaskets found on the ground and those encountered during the dismantling of the piping, smokestacks, and storage tanks should be assumed to be asbestos-containing. Due to the difficult nature of abating the gasket materials prior to the dismantling/demolition of the facility, PSI recommends that BNC Engineering, a TDH licensed asbestos abatement contractor, and a TDH licensed individual asbestos consultant coordinate efforts in order to devise a method of abatement that is in accordance with all applicable state and federal regulations. The method of abatement selected should then be incorporated into the design phase of the project.

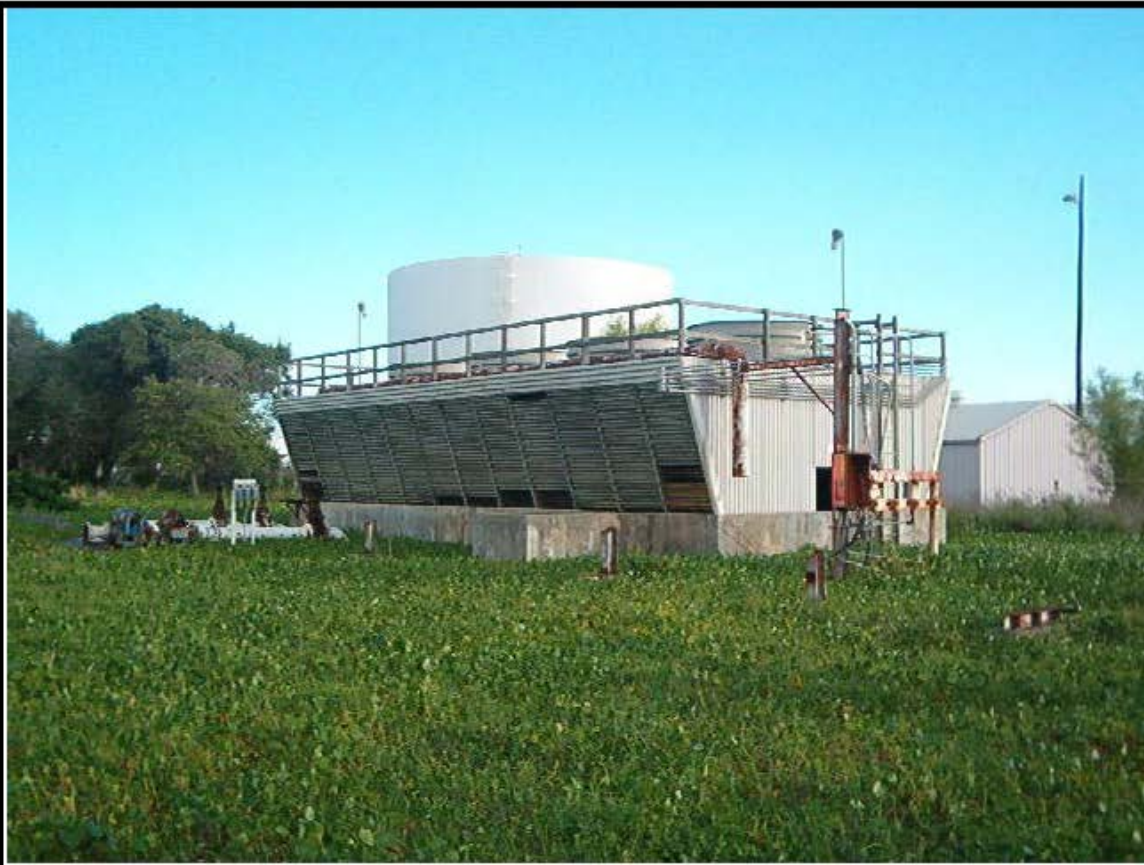
3. View of corrugated cement-asbestos panels located at cooling towers in Area B.

- B. Homogeneous Area No. 06 consists of approximately 4,500 square feet of corrugated cement-asbestos panels located throughout the structural walls of the two (2) cooling towers in Area A. The roof decks, filling materials, and exhaust casings are constructed of non-suspect materials. The corrugated cement-asbestos panels are non-friable and in damaged condition. The corrugated cement-asbestos panels were found to contain 15% Chrysotile asbestos and should be removed and disposed of by a TDH licensed asbestos abatement contractor prior to any dismantling or demolition activities.

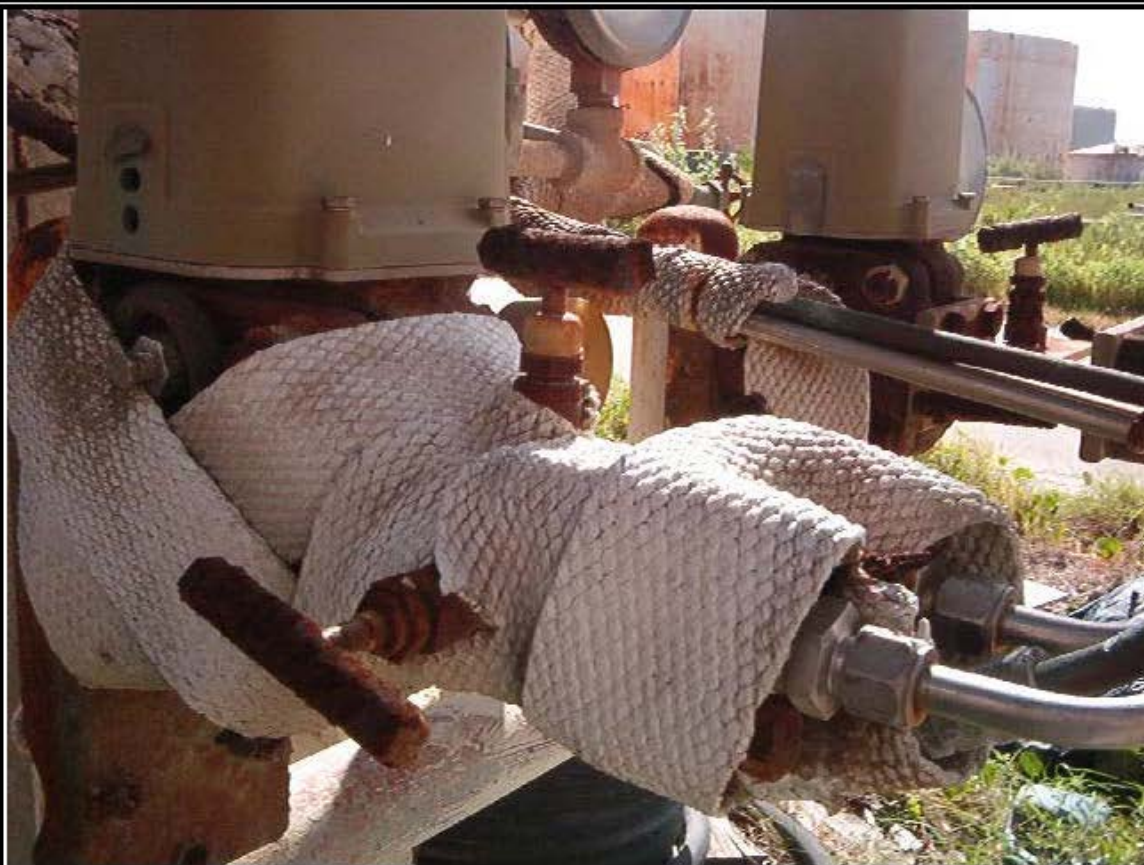
- C. Homogeneous Area No. 13 consists of approximately 100 linear feet of white insulation cloth applied to various damaged areas in the piping system at Area C. This material is friable and in damaged condition. The white insulation cloth was found to contain 45% Chrysotile asbestos and should be removed and disposed of by a TDH licensed asbestos abatement contractor prior to any dismantling or demolition activities.

4. View of white insulation cloth located at various patched areas in the piping throughout the facility.

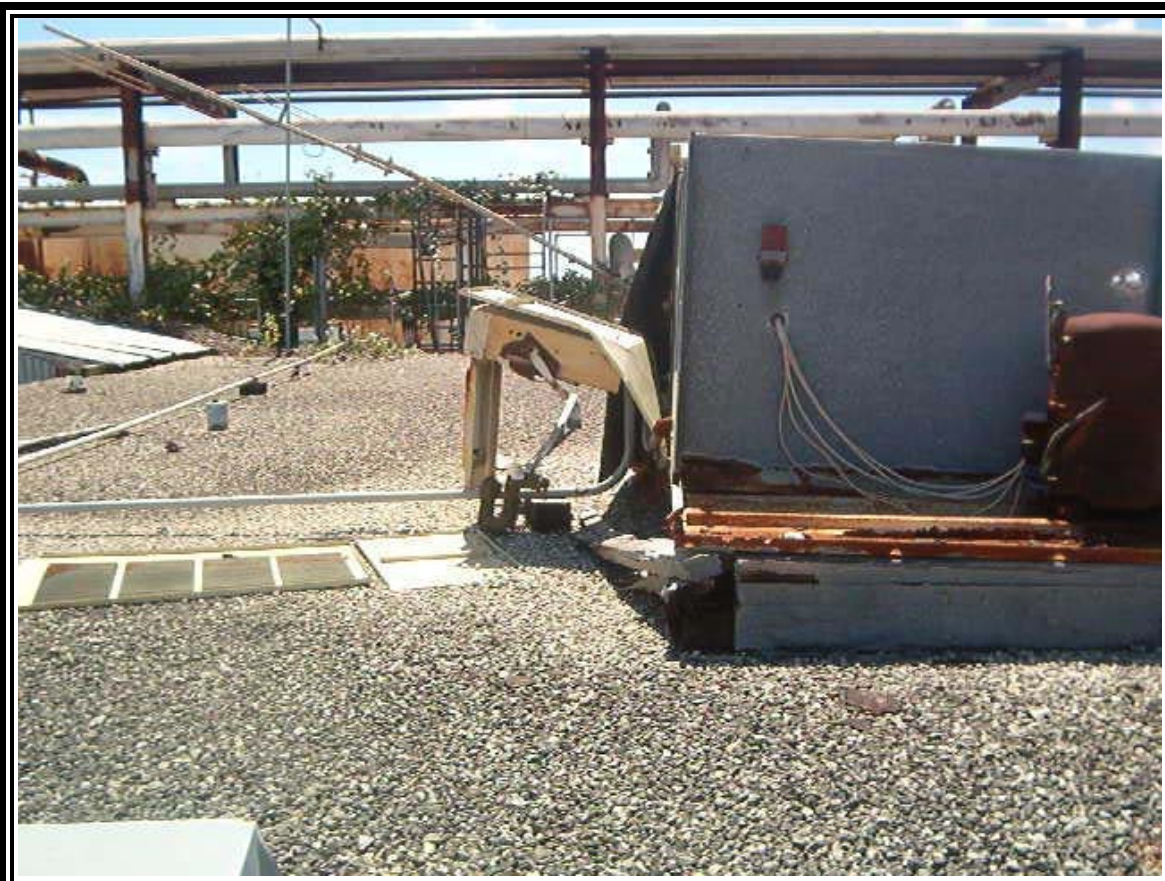
5. View of black roofing mastic located at the roof of the Main Control Room in Area E.

- F. Homogeneous Area No. 26 consists of approximately 50 square feet of black roofing mastic applied to the base of the roof-mounted HVAC unit, the condensation drain line, vents and at various areas on the roof of the Control Room in Area E. This material is non-friable and in damaged condition. The black roofing mastic was found to contain 10% Chrysotile asbestos and should be removed and disposed of by a TDH licensed asbestos abatement contractor prior to any demolition activities.

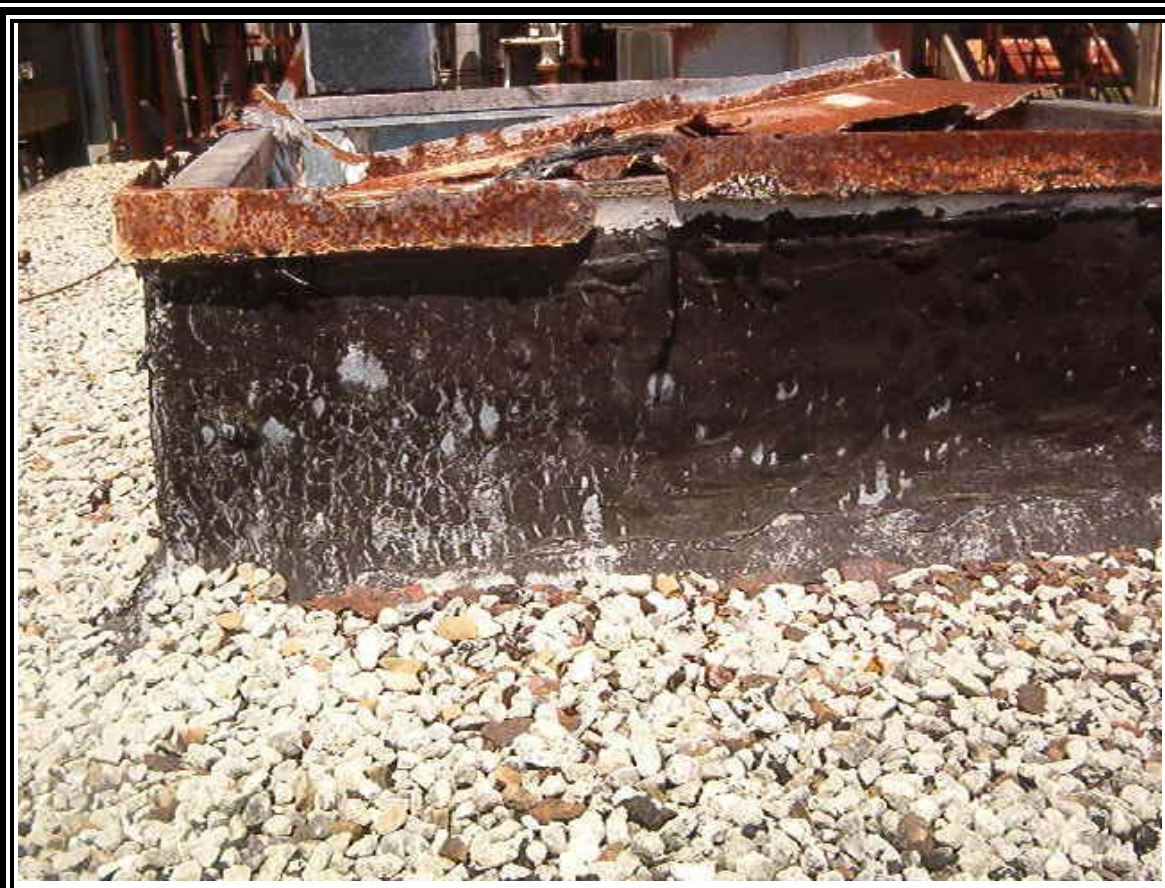
6. View of tar flood coat located at the roof of the Control Room in Area F.

- H. Homogeneous Area No. 33 consists of approximately 150 square feet of tar flood coat located throughout the roof of the Control Room in Area F. This material is non-friable and in damaged condition. The tar flood coat was found to contain 7% Chrysotile asbestos and should be removed and disposed of by a TDH licensed asbestos abatement contractor prior to any demolition activities.
